Re: Request for Information Pursuant to Section 308 of the Clean
Water Act (33 U.S.C. § 1318), Docket No. CWA-308-R01-FY16-05

On October 9, 2015 the U.S. Environmental Protection Agency, Region I (the "Region") conducted an inspection of the Billings Diesel and Marine Services Inc. facility located at 72 Moose Island Road in Stonington, ME (hereafter referred to as the "site" or "Facility"). The Facility was inspected for compliance with the Clean Water Act (the "Act"). The Region received a submittal from the Facility on November 6, 2015 regarding a number of observations that were made during the inspection.

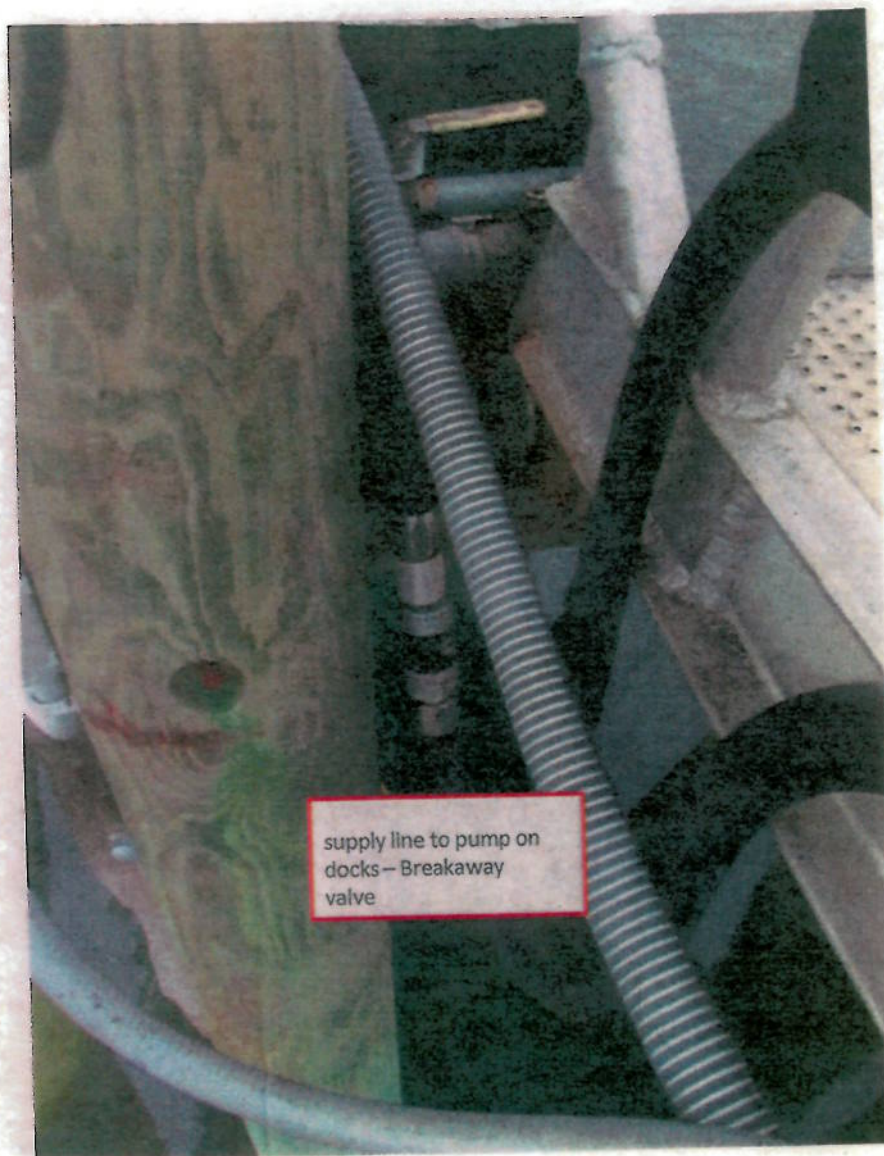
supply line to pump on
docks – Breakaway
valve

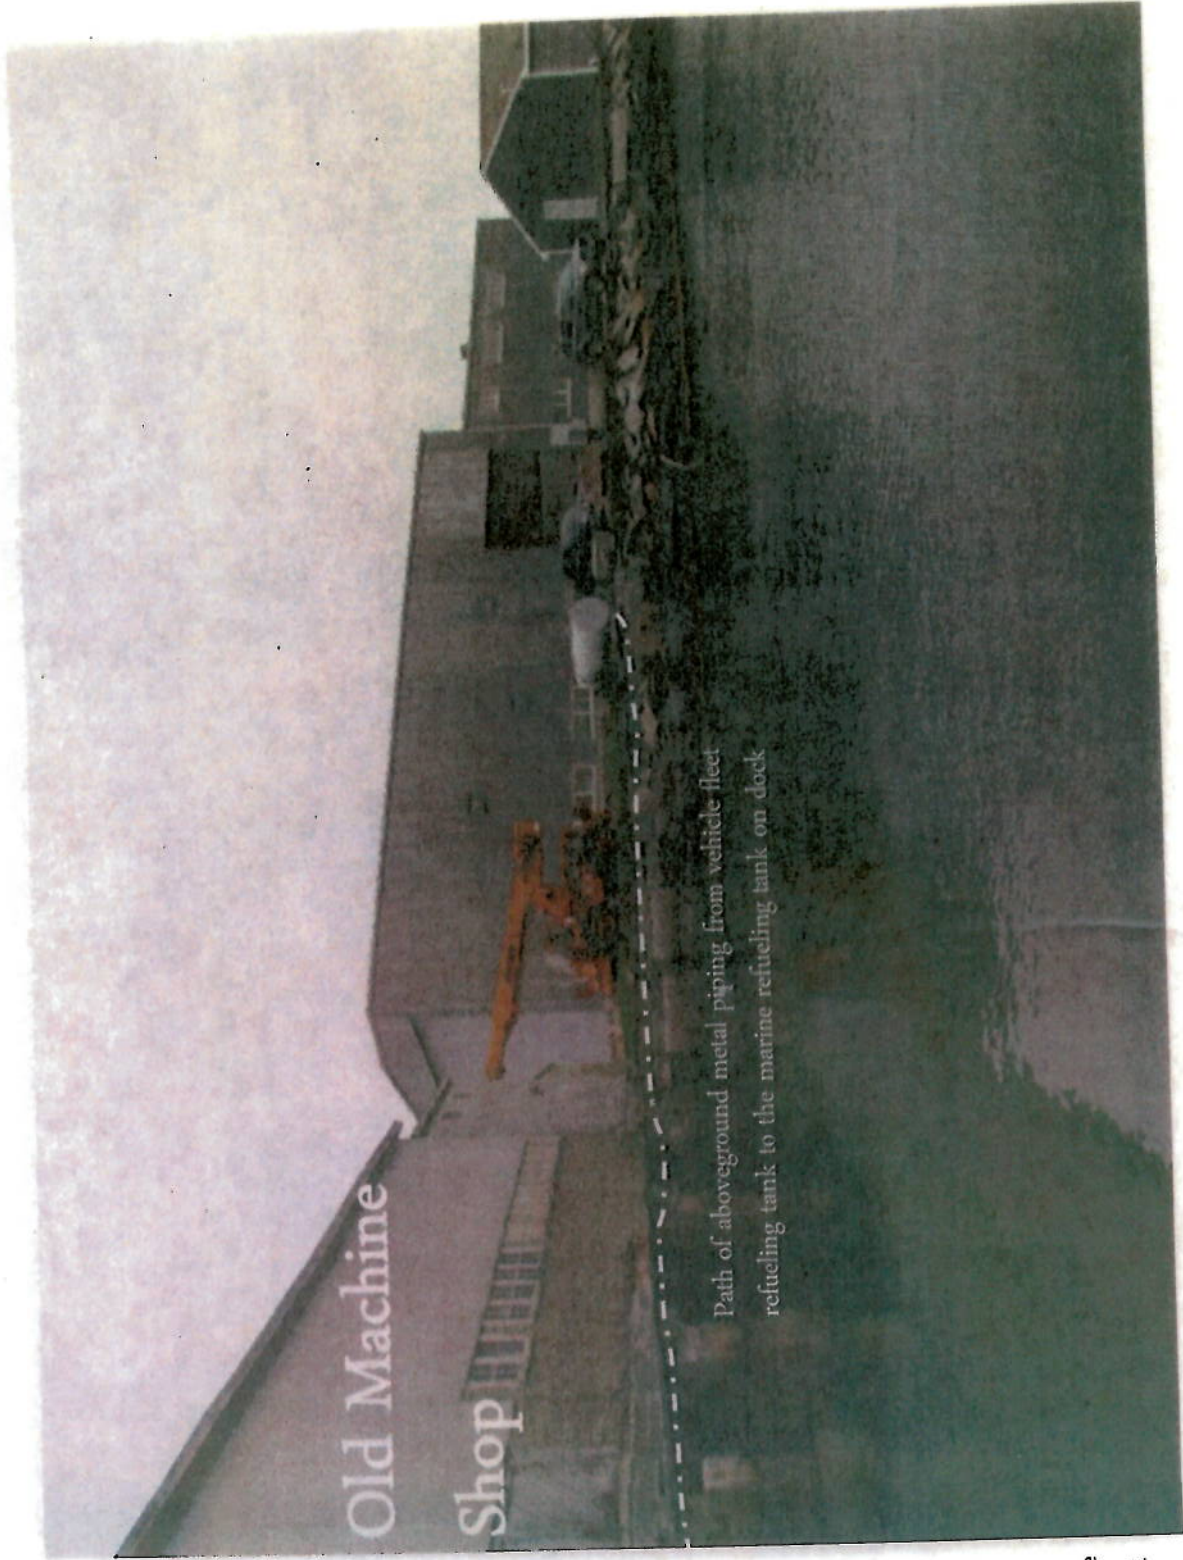
Piping exists between the oil storage tank (slide 36) that is used for fueling the Facility's fleet of vehicles and the Marine Refueling Tank located on the dock at the end of the Old Machine Shop (Slide 46). The piping is approximately 1 inch steel pipe (slide 36, 37, & 47). The purpose of the piping is to be able to transfer fuel to the Marine Refueling tank as make-up in case the Marine tank ever runs out. According to Jim Foley, this scenario rarely happens. The soundness of the piping's integrity and the potential of failure due to its alignment along the shore and down the side of the Old Machine shop was questioned by Alex Rosenberg.

Path of aboveground metal piping from vehicle fleet refueling tank to the marine refueling tank on dock

- Ensure piping from fueling tank to tank on dock is adequate and secure (rusty)
 - Implement secondary containment measures for the drums of used waste oil in the old machine shop.
